Use Attainability Analysis

WBID 0713 McKinney Creek

Submitted by
SES, Inc.

To
Missouri Department of Natural Resources
Water Protection Program

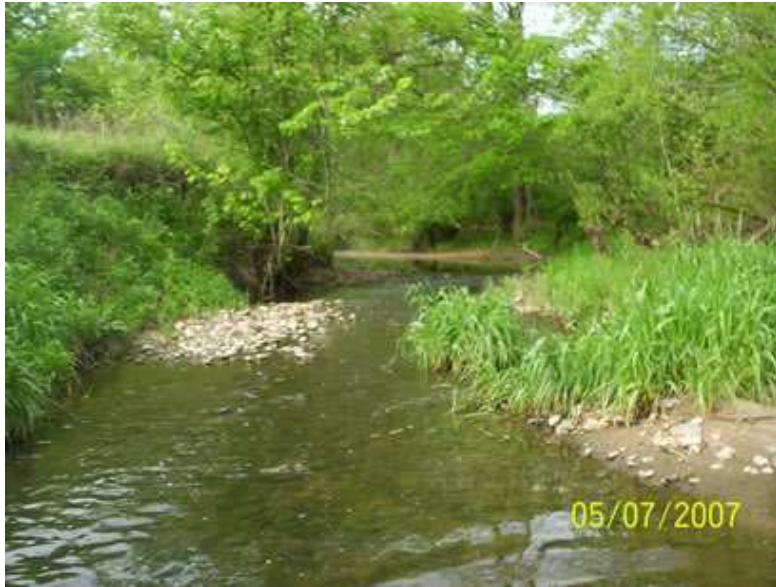
Site# 1 Photo ID# 2, Upstream

WBID # 713 **Site #** 1
Mark # 1 **Dissolved Oxygen (ppm)** 9.8
Upstream Views Physical Dimensions: Is there any water present at this view? Yes

If so, is there an obvious current? Yes

% of Channel Feature				
Riffle	25				
Run	12				
Pool	63

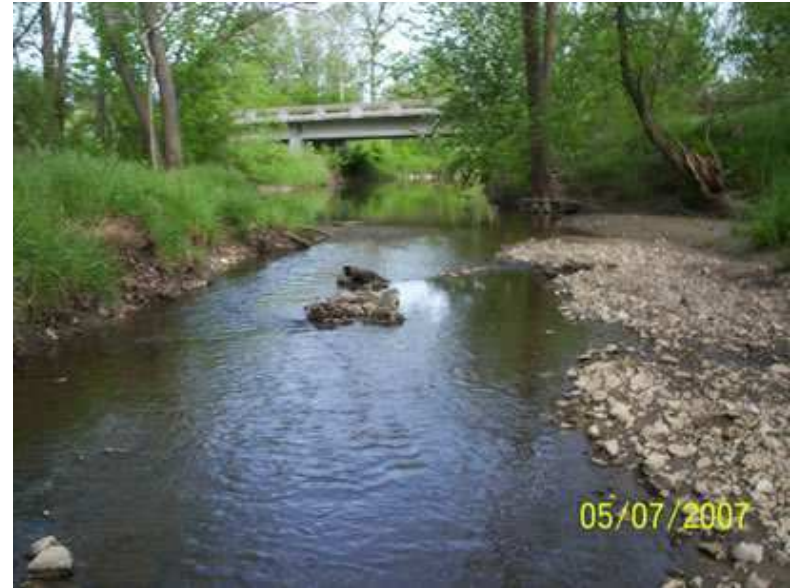
Site# 1 Photo ID# 1, Downstream

Downstream View's Physical Dimensions: Is there any water present at this view? Yes

If so, is there an obvious current? Yes
